Re: Old Town Hall Building – Structural Assessment
1 Milton O Fountain Way
Warren MA 01083

This letter is a structural assessment of the Old Town Hall building located at 1 Milton O Fountain Way and addresses the Foundation, Masonry Walls, Floors, Roof and the Clock Tower. Attached to this letter are captioned photos, cost estimates for the building renovation per current code to the former use group of each floor, being Business use on the first floor and Assembly use for the public on the second floor, as requested an estimate for the demolition of the building is included on the last page.

Structural Assessment:

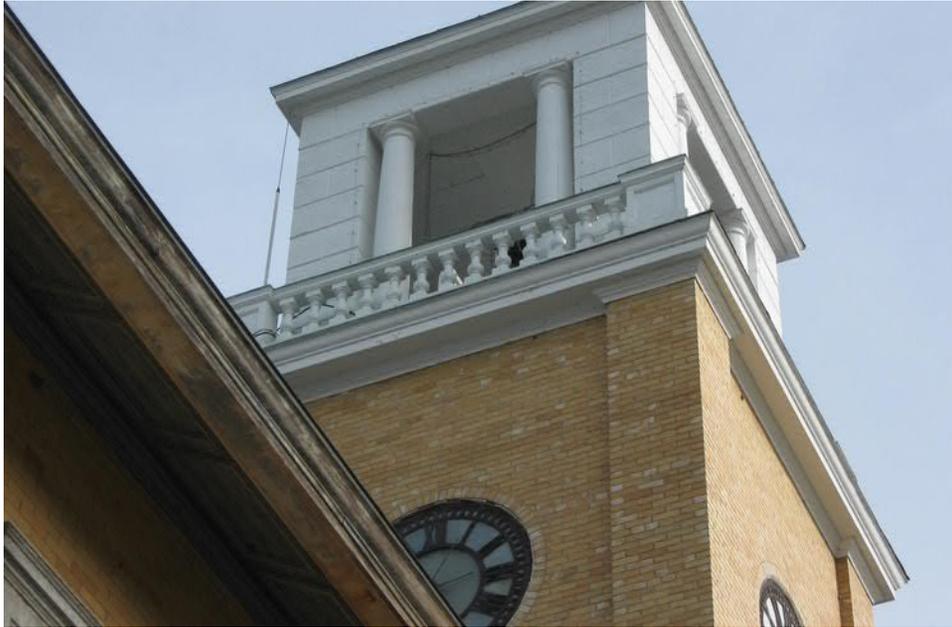
Clock Tower
IMG_2727

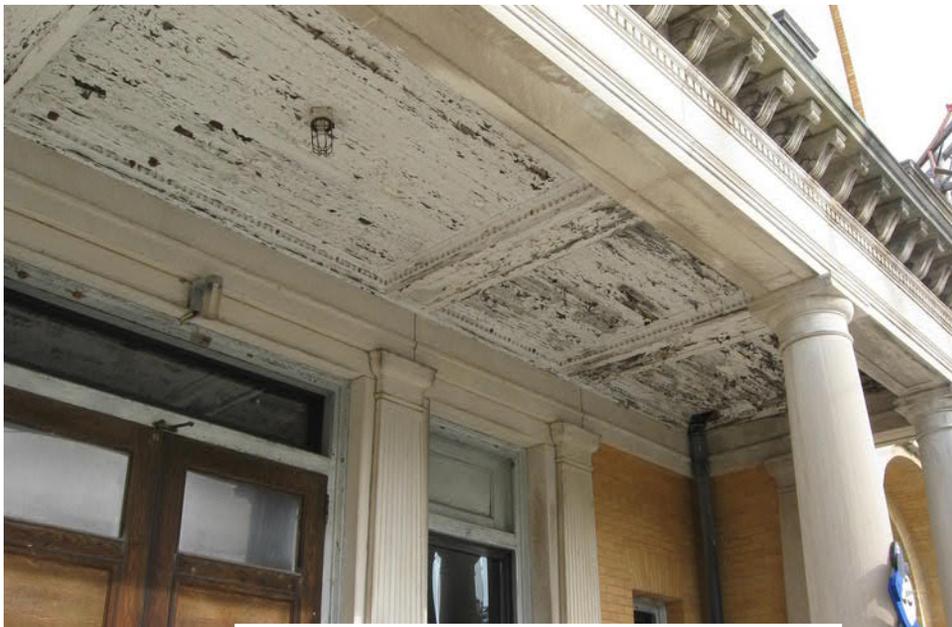
Portico - Rotted Wood Deck - East Side
IMG_2728

- c. The limestone columns at the main entrance Portico are in reasonably good shape with some joints requiring repointing. The Portico limestone should be cleaned as should all the face brick on the building. It was noted that the wood roof deck of the portico is rotted and should be replaced.

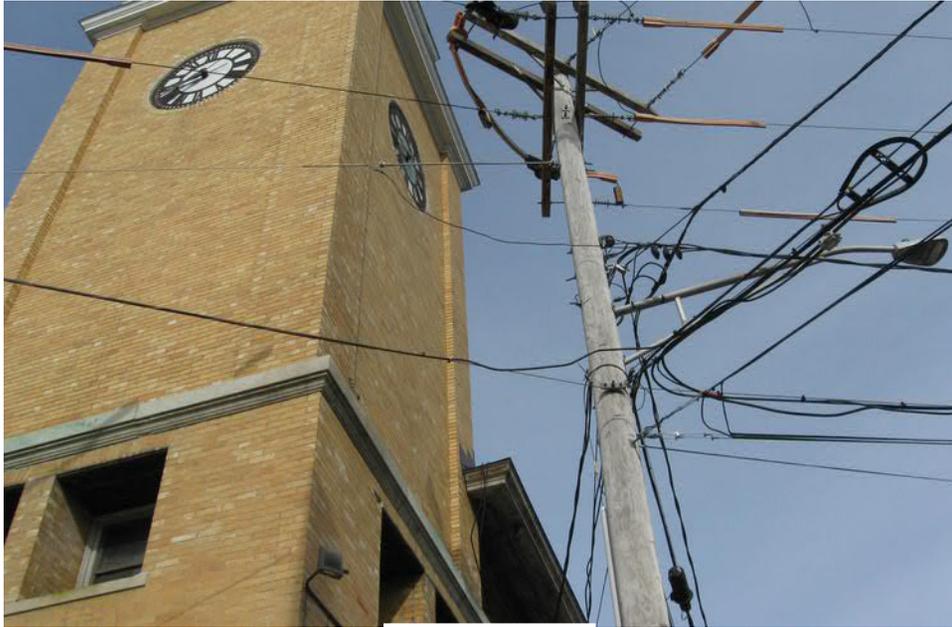
Clock Tower
IMG_2731

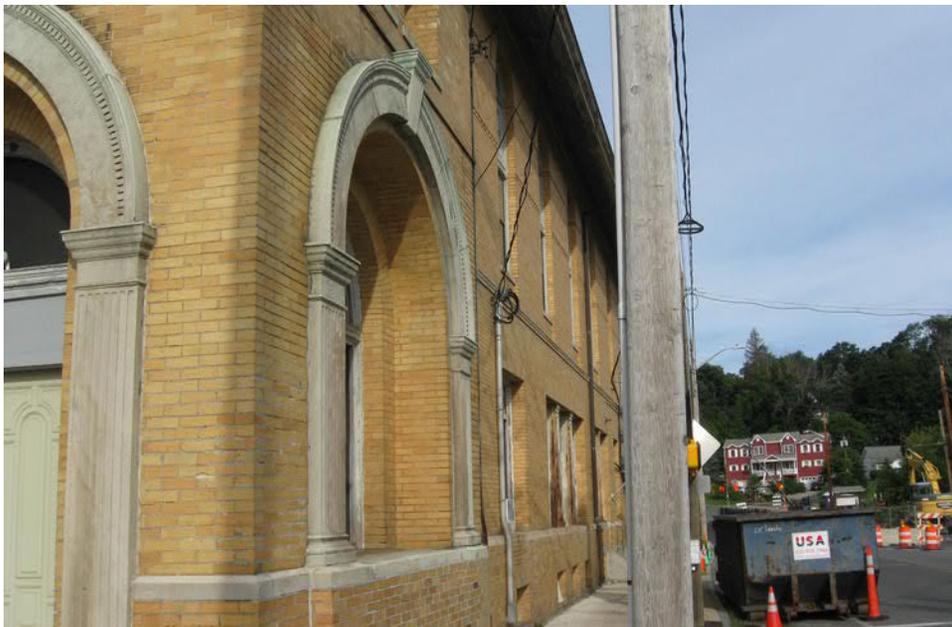
Base - Clock Tower North Side
IMG_2732

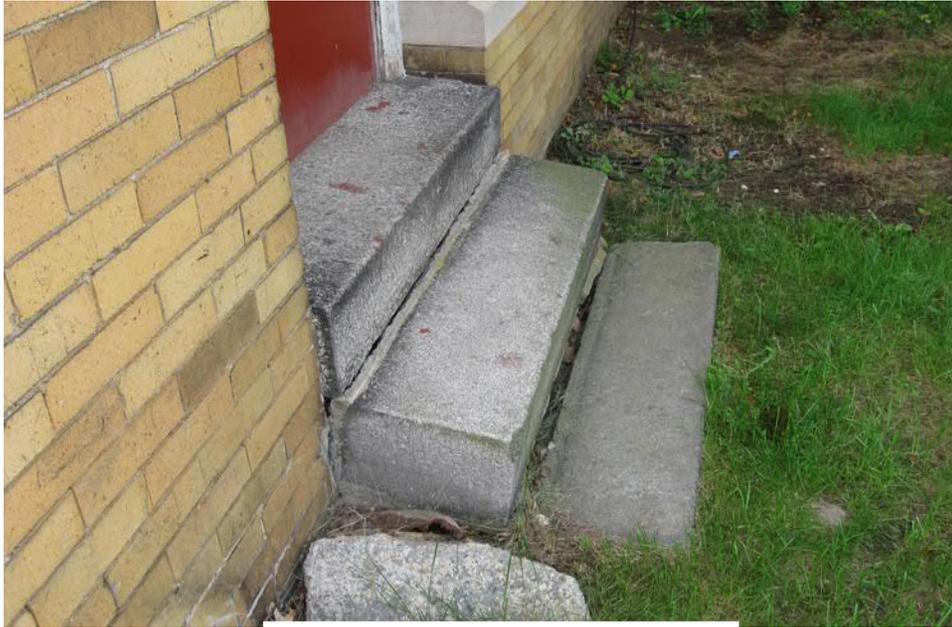
Settlement of Steps - West Side
IMG_2743

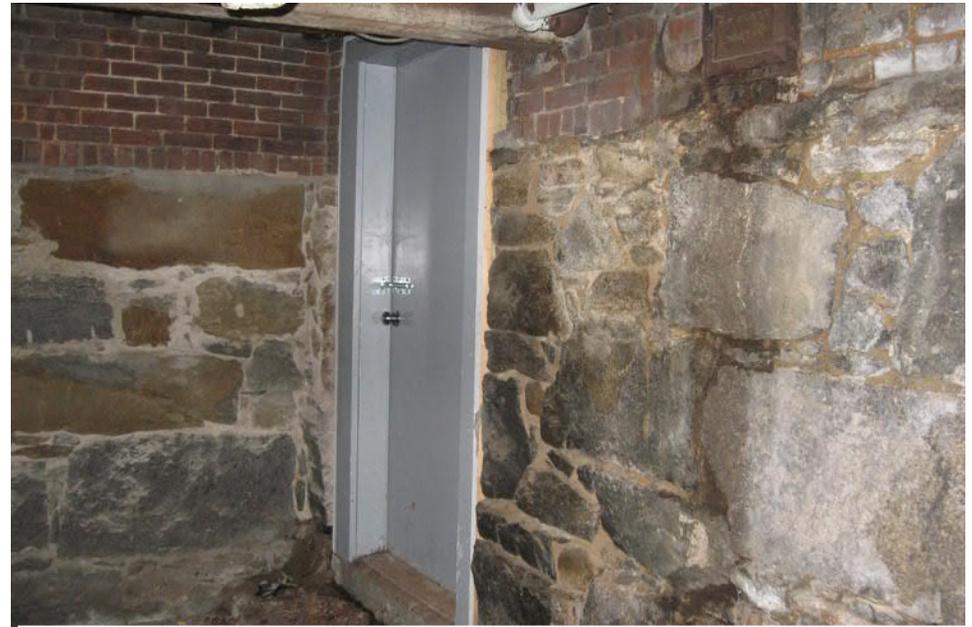
Rubble Stone and Brick Foundation - Basement Door South Side
IMG_2747

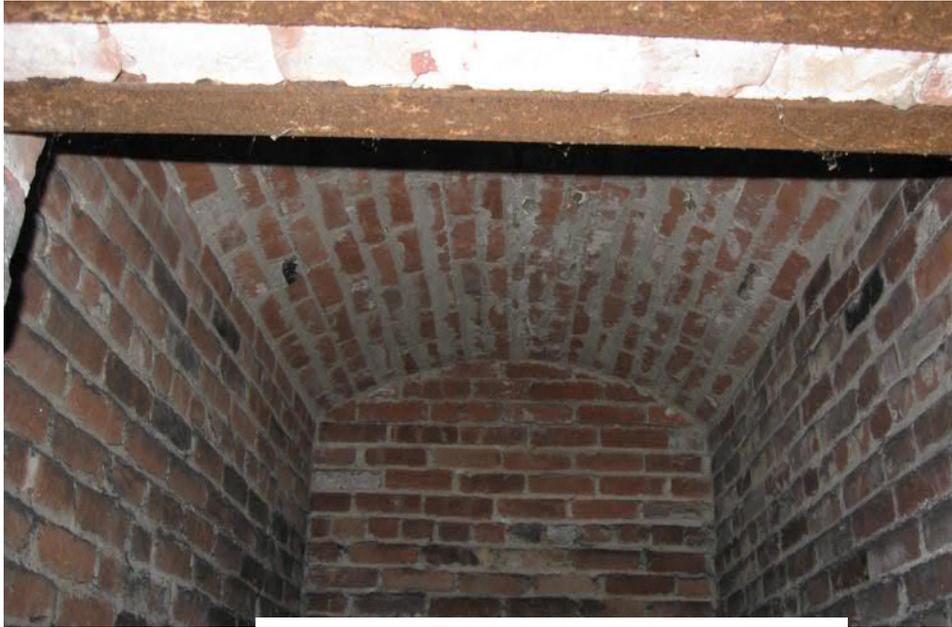
Basement - Brick Arch - Unknown Use
IMG_2752

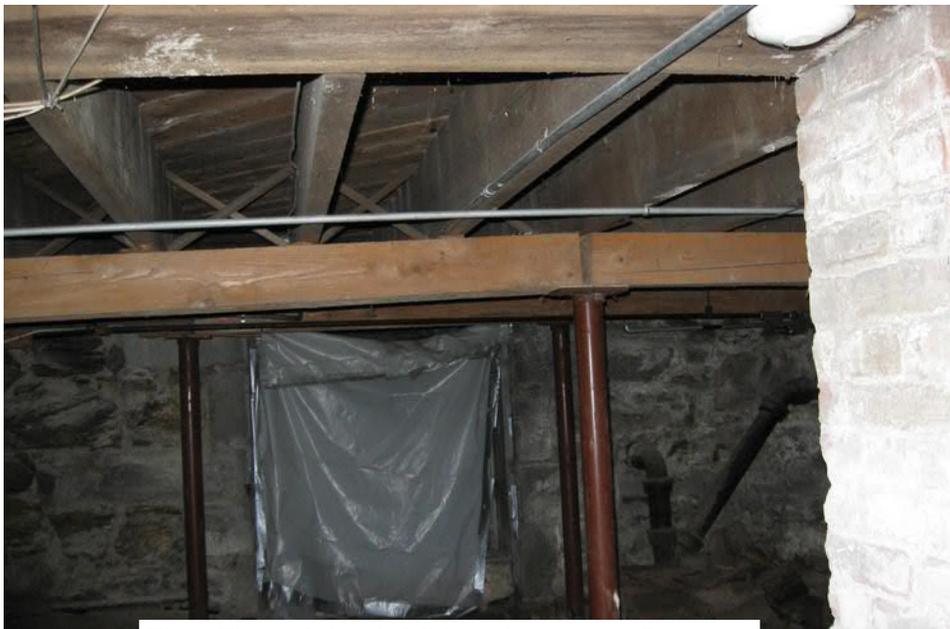
First Floor Joist Additional Support Beams
IMG_2757

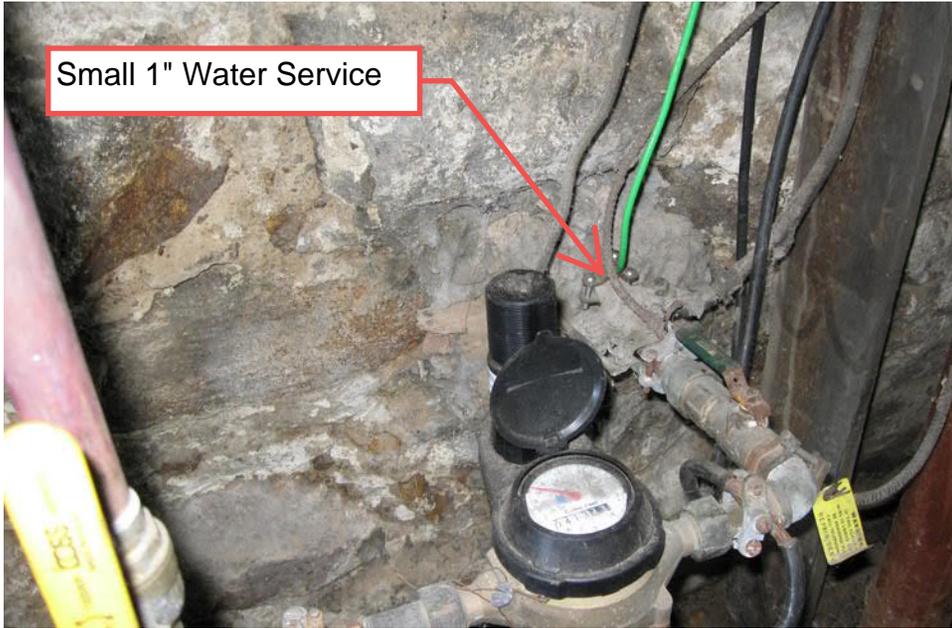
IMG_2760

Small 1" Water Service

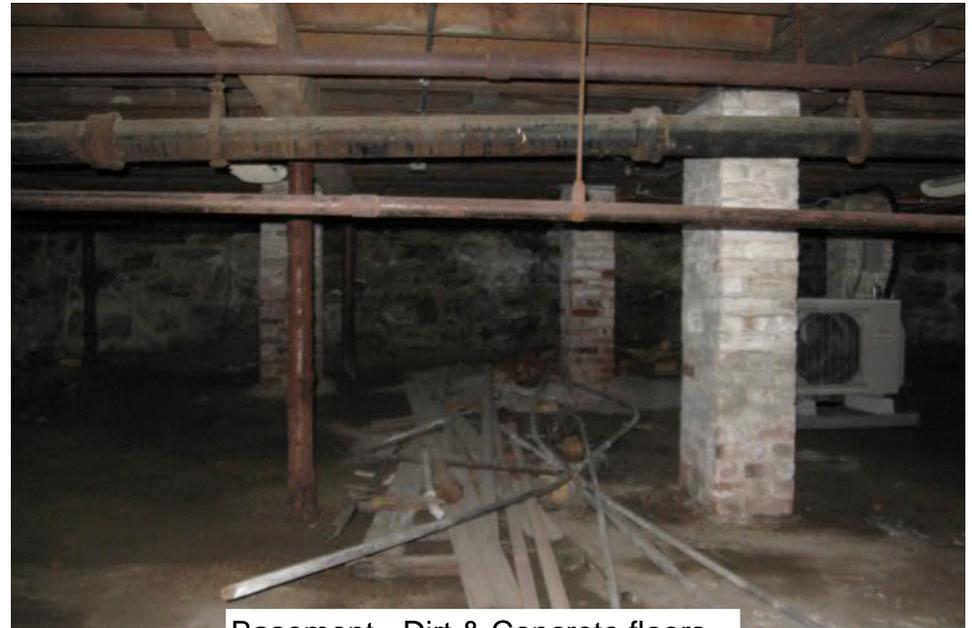
IMG_2759

Basement - Dirt & Concrete floors

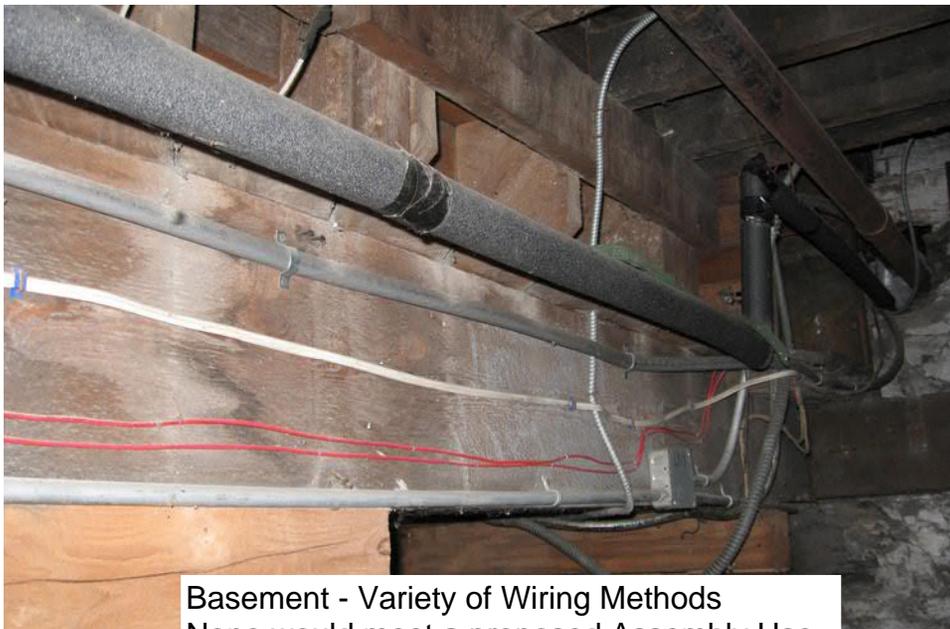
IMG_2765

Basement - Variety of Wiring Methods
None would meet a proposed Assembly Use

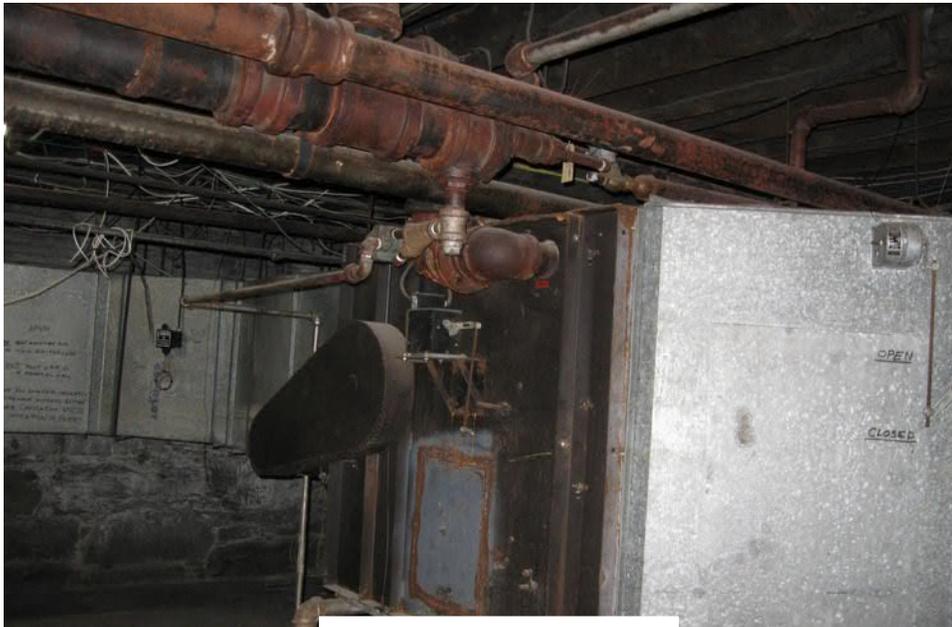
IMG_2769

Abandoned Air Handler

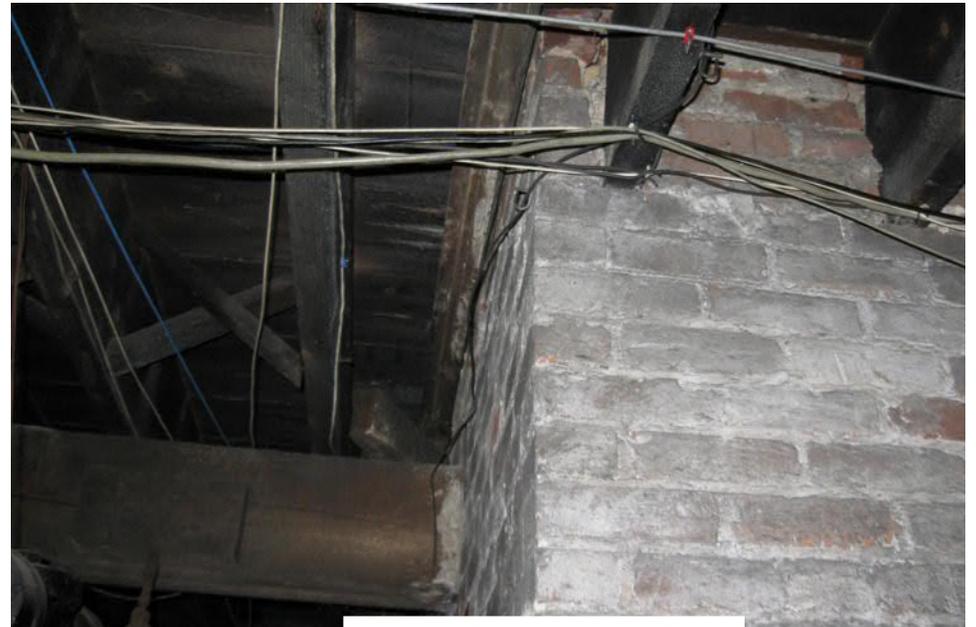
Wiring - Typical Brick Piers
IMG_2771

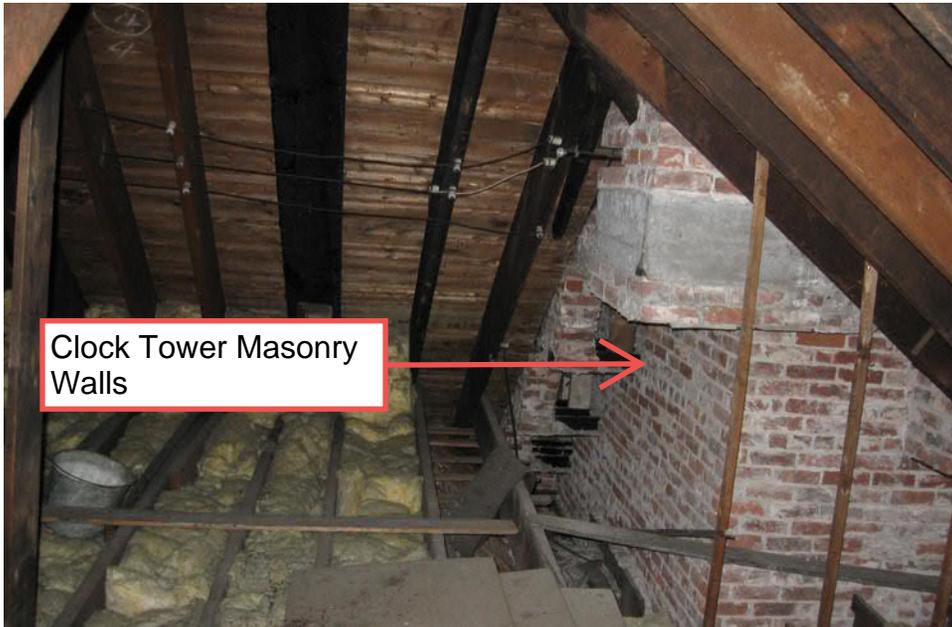
Clock Tower Masonry Walls

In Attic
IMG_2786

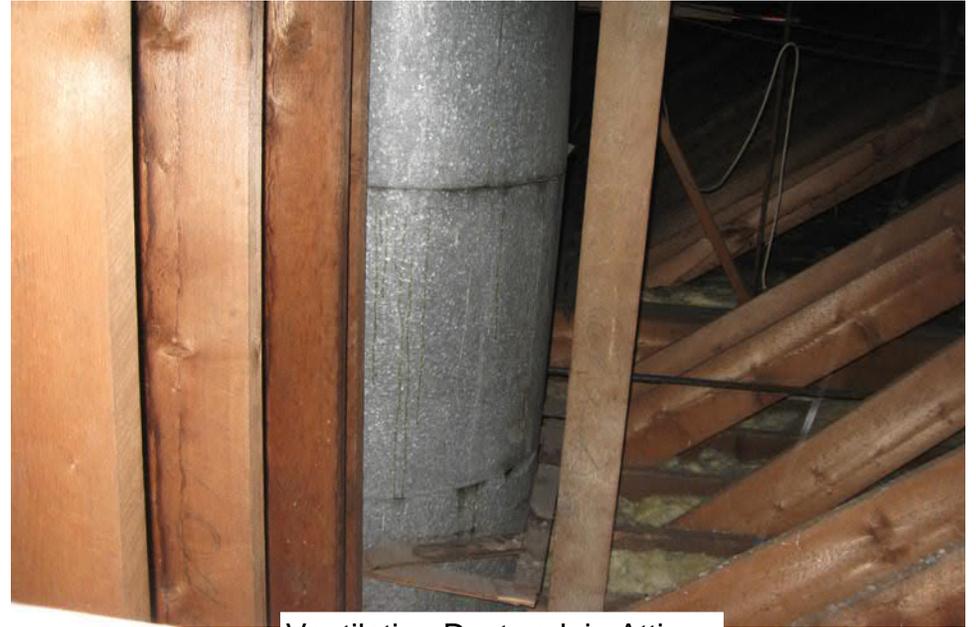
IMG_2789

Center Flat Roof Area

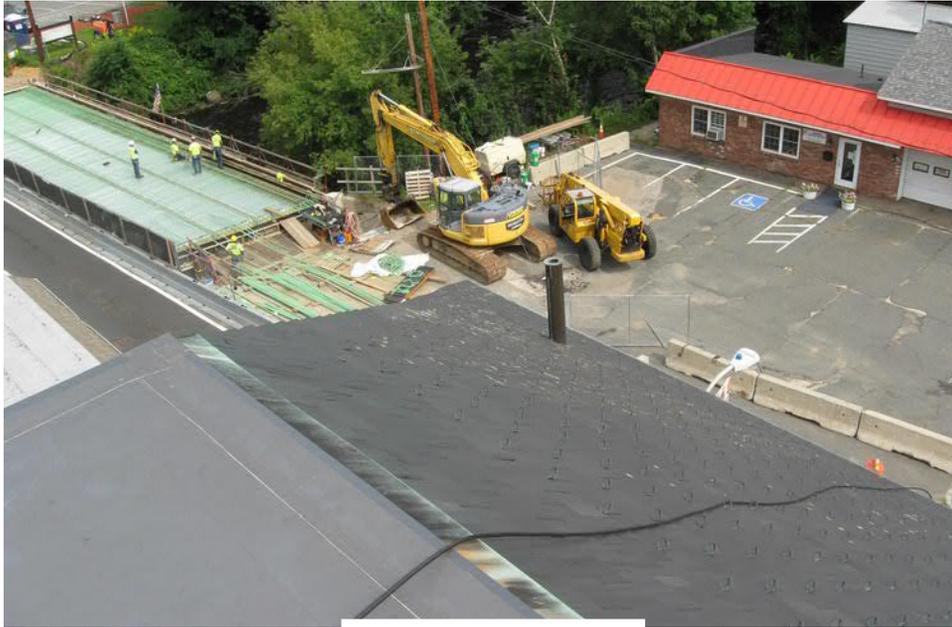
NW Corner of Roof
IMG_2797

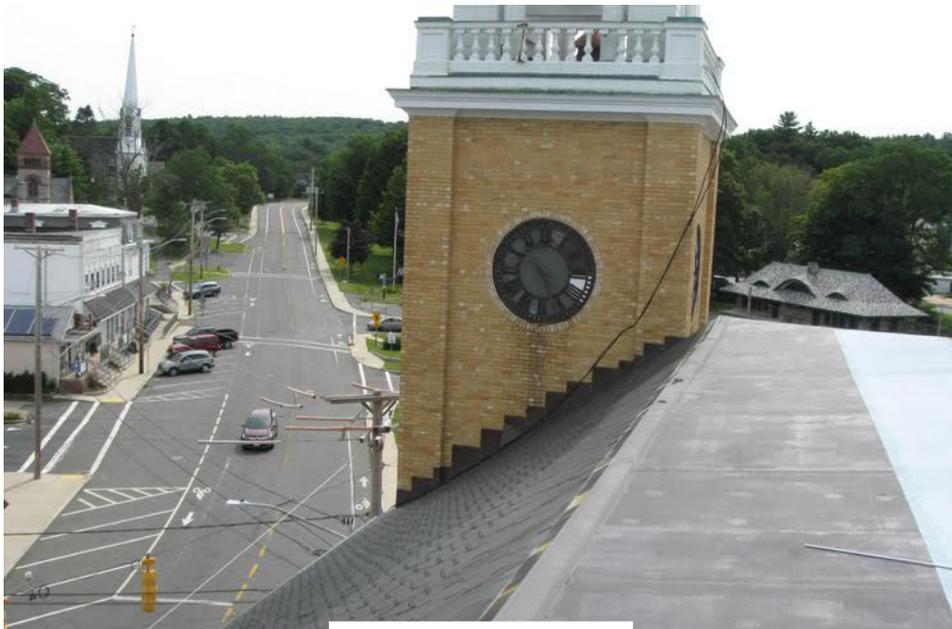
NE Corner of Roof
IMG_2798

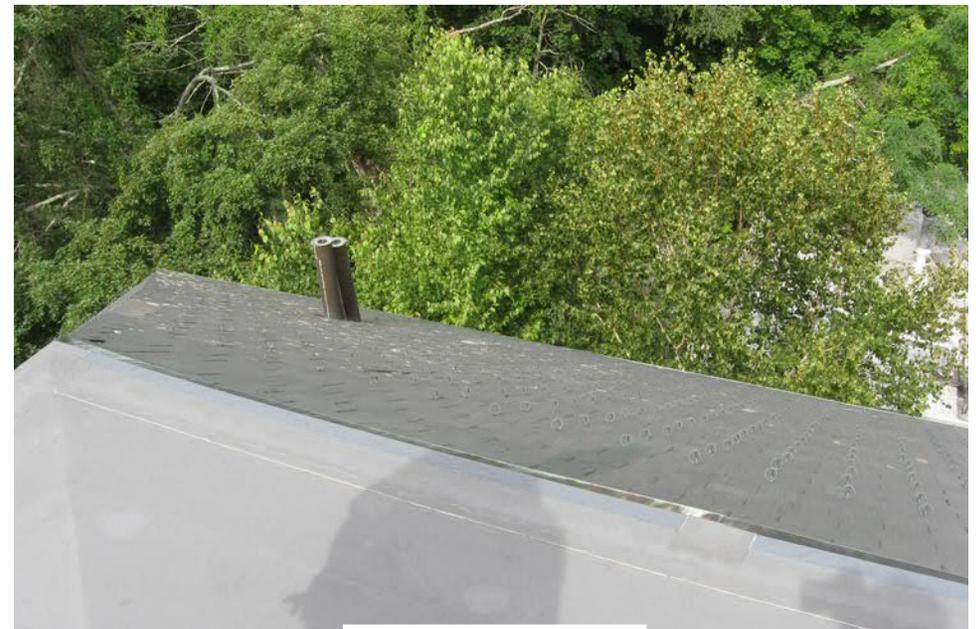
SE Corner of Roof
IMG_2796

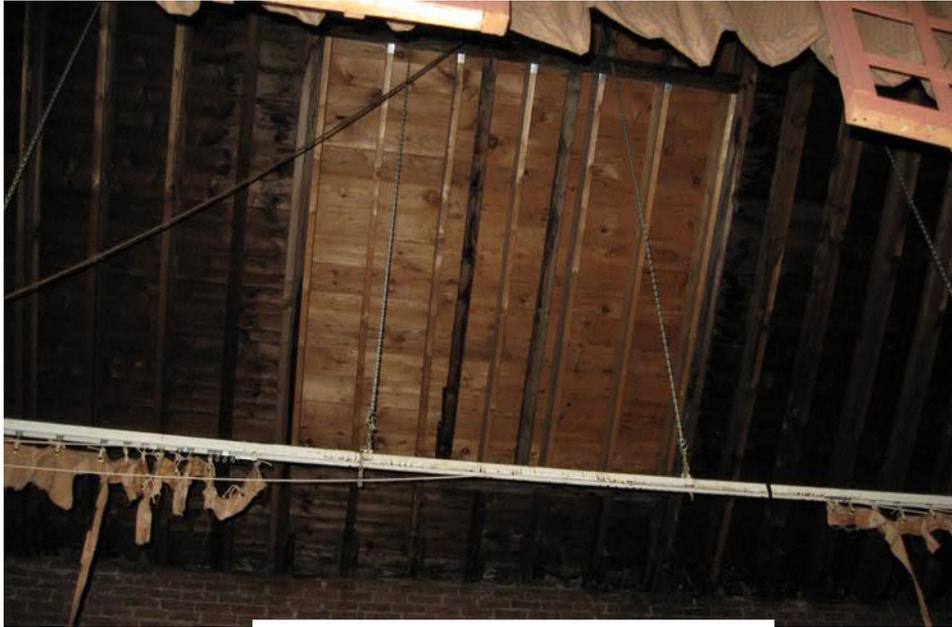
Roof Framing Over Rear of Stage
IMG_2805

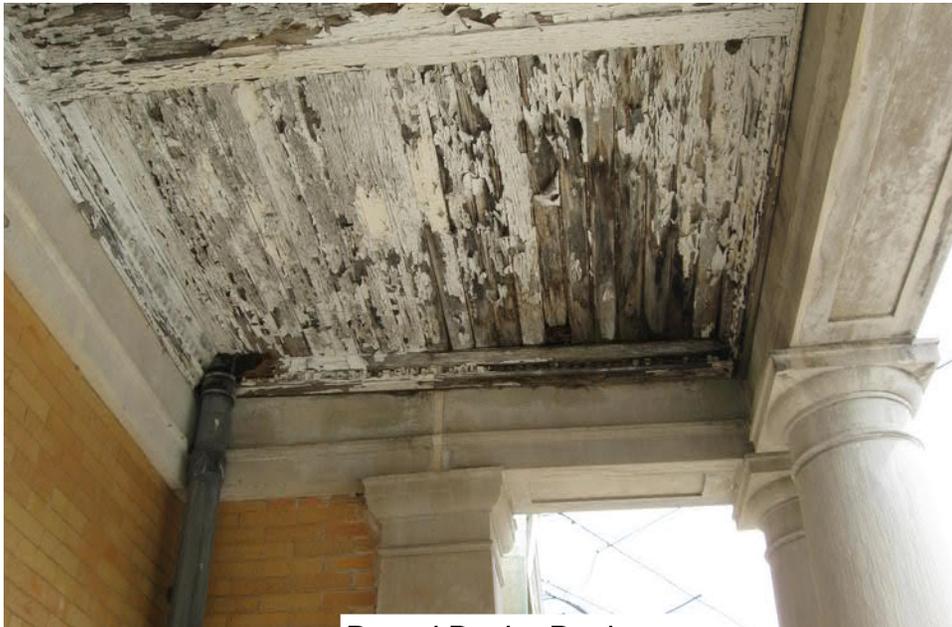
Rotted Deck - Portico
IMG_2806
